Case Study

Historic Restaurant

Bennington, VT

A restaurant kitchen in a repurposed horse barn in rural VT

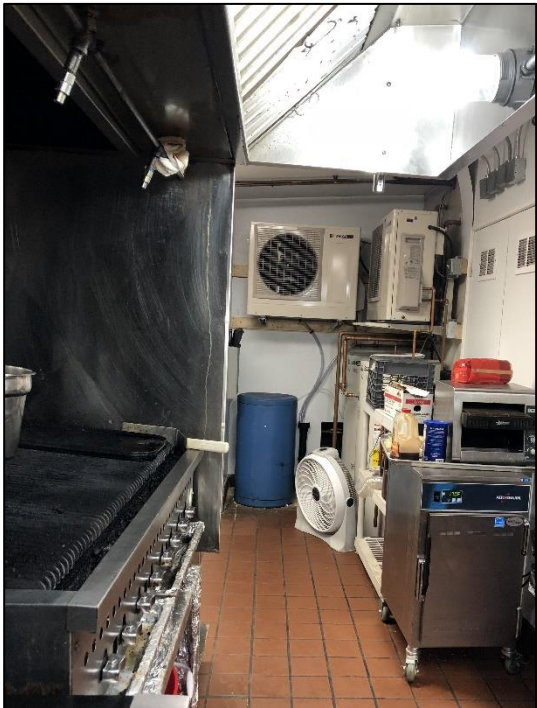
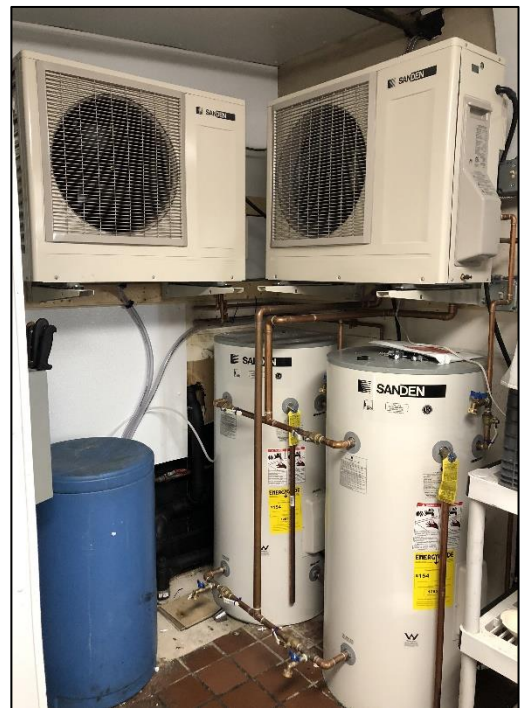
The new hot water system included two 15,000 BtuH Sanden Heat Pump Water Heaters and two storage tanks, installed in the kitchen. One of the goals of the project was to reduce the carbon footprint of the business, and the low global warming potential of the CO₂ refrigerant in the Heat Pumps was an additional benefit.

Propane use was decreased by 70%, or 3,600 gallons/year, and overall energy use was decreased by 52%, or 51,000 kWh/yr, although the Heat Pump Hot Water system is only one of several energy efficiency upgrades implemented by the restaurant. By installing the heat pumps in the kitchen, heat is extracted from the kitchen to produce hot water, effectively reducing the kitchen temperature and contributing to a more comfortable working environment as a by-product.
